TEST REPORT

SLIP RESISTANCE CLASSIFICATION OF **NEW PEDESTRIAN SURFACE MATERIALS**

Moda Altro Verona, Brown, Timber Flooring

Issue Date: 04-03-2022

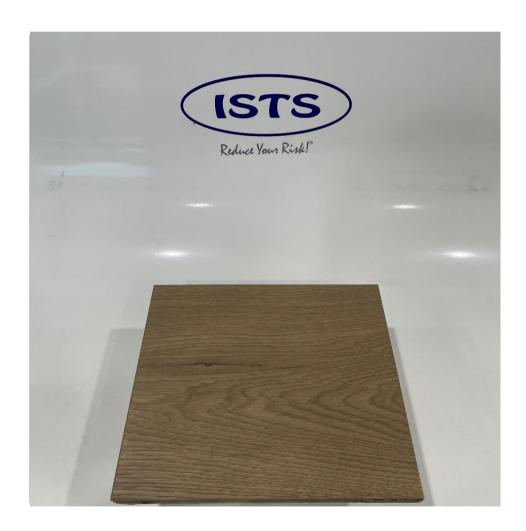
TEST PRODUCT IMAGE

Product Description: Moda Altro Verona, Brown, Timber Flooring

Test Date: 03-03-2022
