TEST REPORT SLIP RESISTANCE CLASSIFICATION OF **NEW PEDESTRIAN SURFACE MATERIALS**

AS/NZ: 4586.2004 **Appendix A - Wet Pendulum Testing Appendix B - Dry Friction Testing**

Product Description: Loft Collection, Timber Board, Brown, 16x20cm

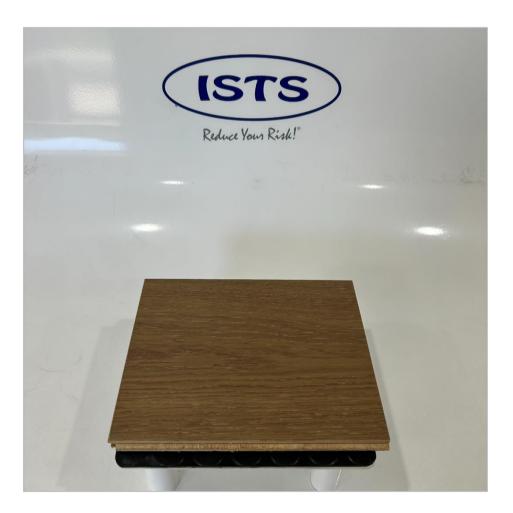
TEST PRODUCT IMAGE

Product Description: Loft Collection, Timber Board, Brown, 16x20cm
